Historical Survey of Multi-Story Building Collapses Due to Fire

Beitel, J. J., Hughes Associates, Inc
Iwankiw, N. R., Hughes Associates, Inc.

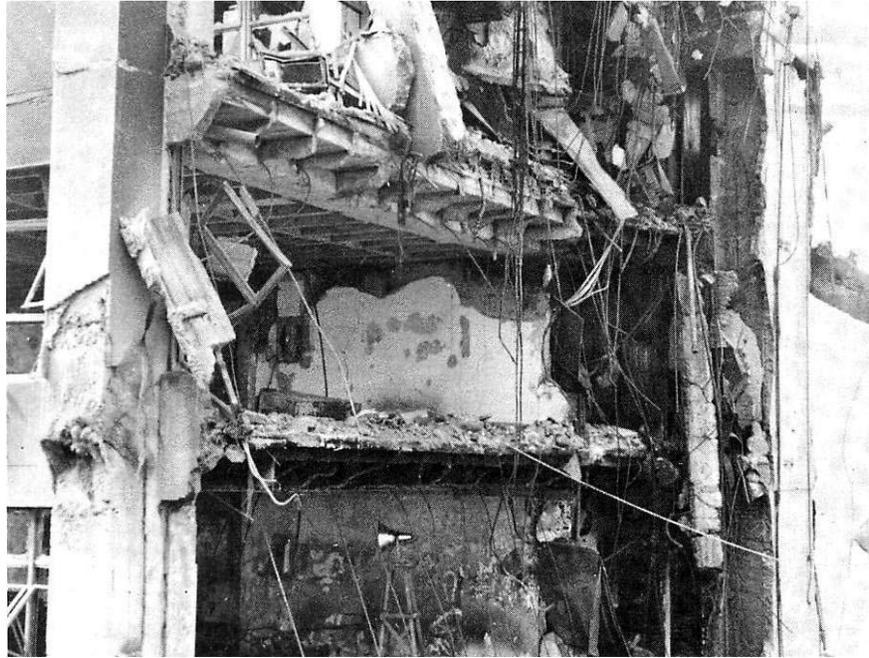
Among the other prior fire events of interest, Sao Paulo experienced one of the biggest fires in Brazil on May 21, 1987, which precipitated a substantial partial collapse of the central core of the CESP Building 2, see Figure 1. This was a 21-story office building, headquarters of the Sao Paulo Power Company (CESP). Buildings 1 and 2 of this office complex were both constructed of reinforced concrete framing, with ribbed slab floors.

Figure 1 CESP 2 Core Collapse in Sao Paulo, Brazil

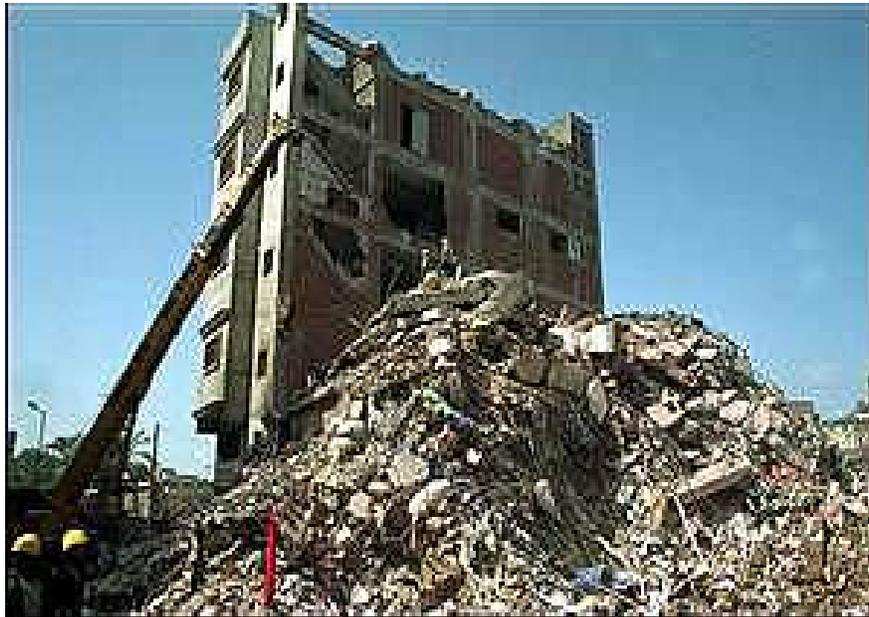
A fire-initiated collapse of a 6-story reinforced concrete textile factory occurred in Alexandria, Egypt on July 19, 2000 (Reuters News, 2000; BBC News, 2000). The fire started in the storage room at the ground floor. Fire extinguishers were non-functional, and the fire spread quickly before firefighters arrived. Approximately nine hours after the start of the fire, when the blaze seemingly was under control and subsiding, the building suddenly collapsed, killing 27 people. Figure 2 shows a photograph of this collapse.

Figure 2 Collapsed Textile Factory in Alexandria, Egypt
